# Protecting the Environment: Mine Clearance in Skallingen, Denmark

by Martin Jebens [ Danish Coastal Authority ]

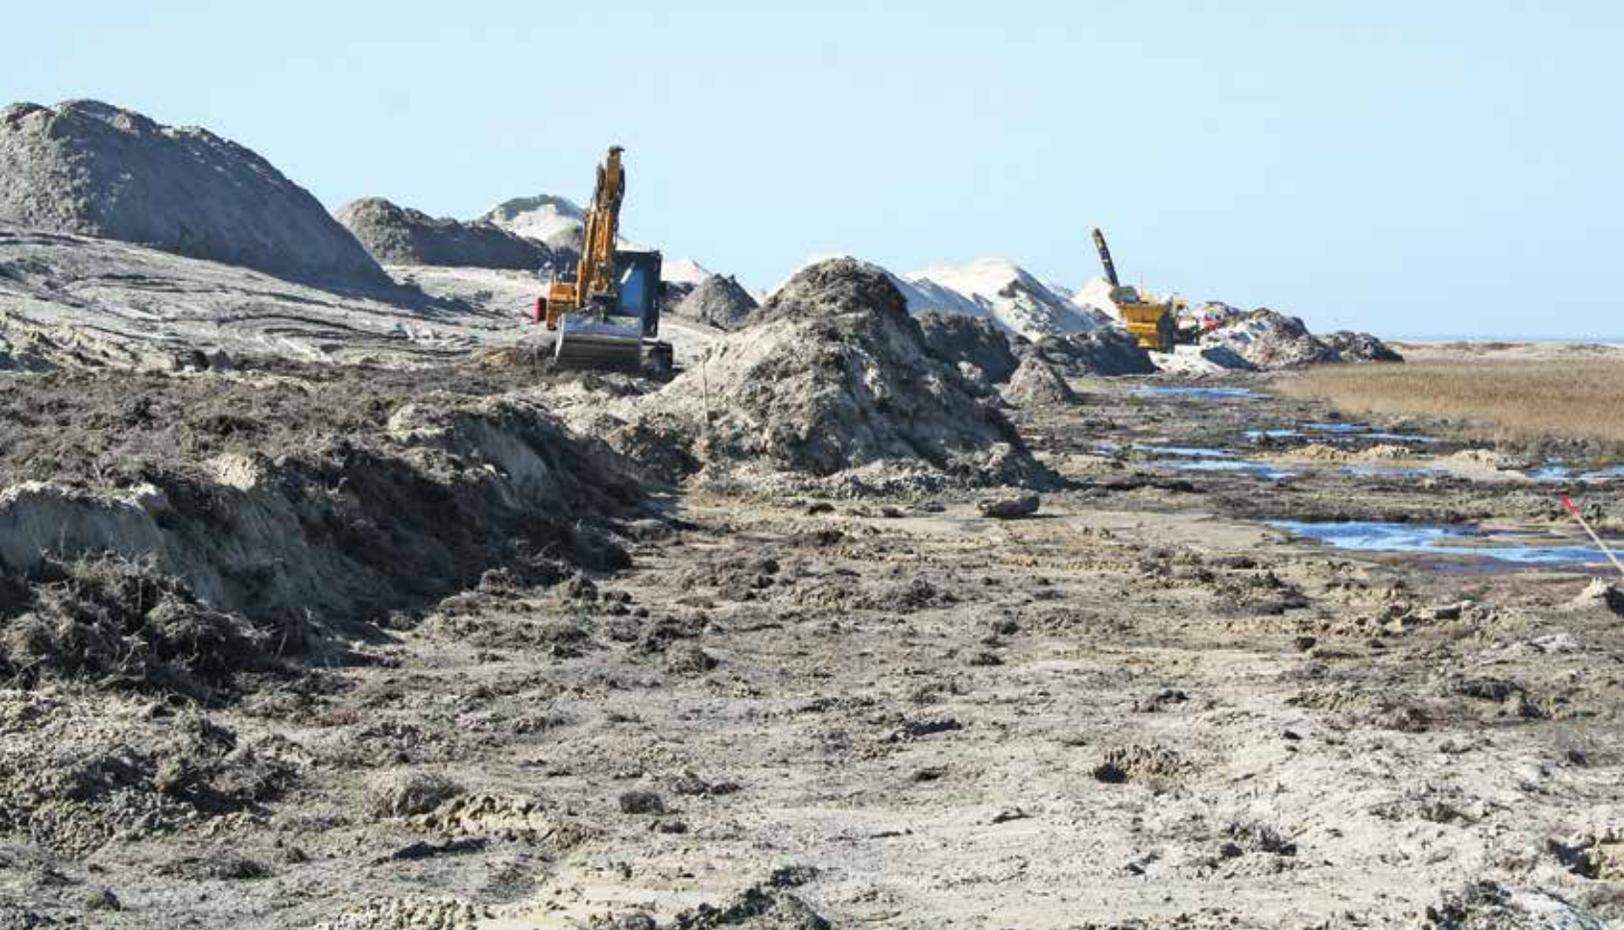
This picture was taken during the reconstruction of the dunes after the mines had been cleared. Without the environmental constraints and rehabilitation of the area it would have had limited value for the wildlife and population following mine clearance.

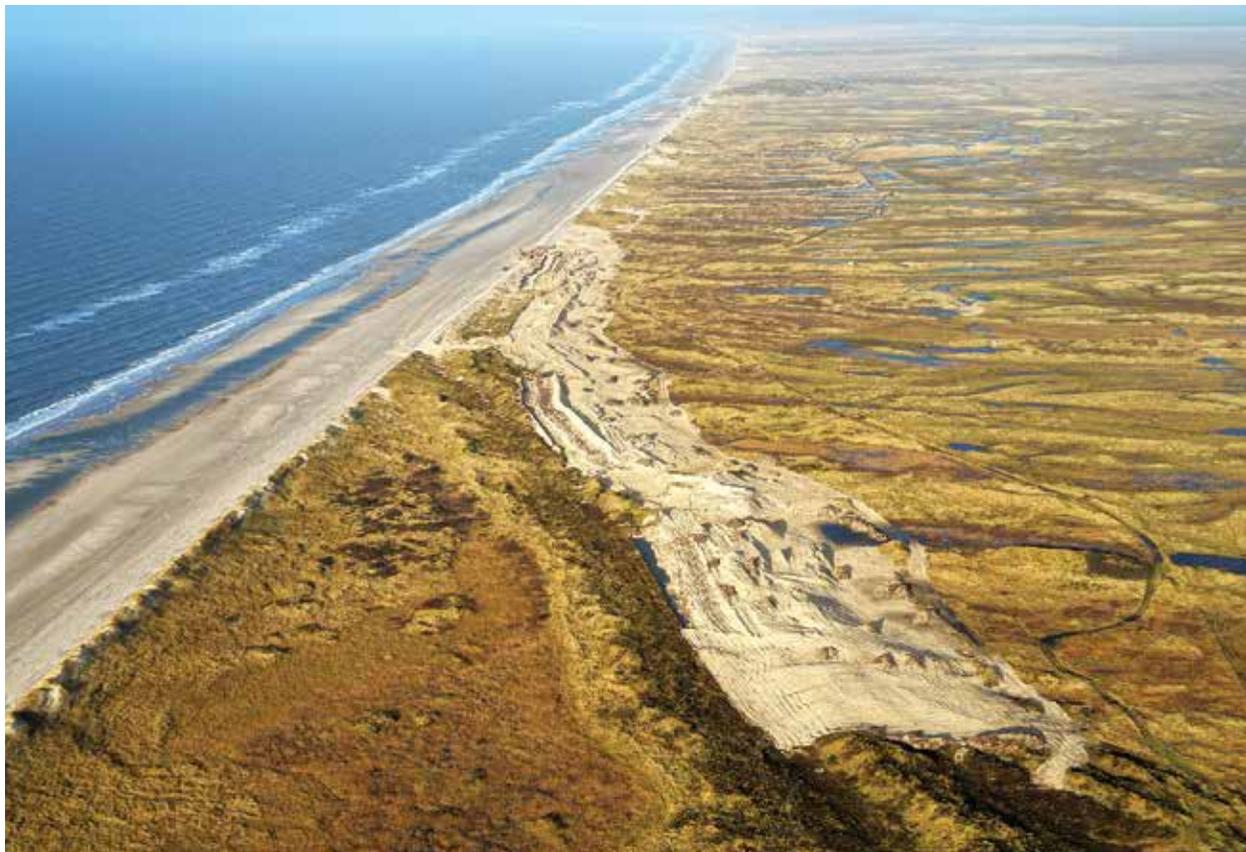
Reestablishing of the dune area in Skallingen.

**Reestablishment of the area.** Dune and beach areas had to be reestablished after clearance using sand from the existing areas. Since the dune area was excavated to an average depth of approximately 4 m (4.37 yd), contours of this area had to be reshaped with a tolerance of 0.5 m (0.55 yd) after clearance was completed. Some dunes could be reestablished with a higher tolerance but only in agreement with the Danish Coastal Authority.

submerged at a considerable depth after 60 years, the vegetation on the dunes prior to the clearance was removed and stored during clearance activities. After reestablishing the dune, it was possible to spread the old vegetation over the top of the dune. The effect was highly positive, and the dunes today appear green (see images above).

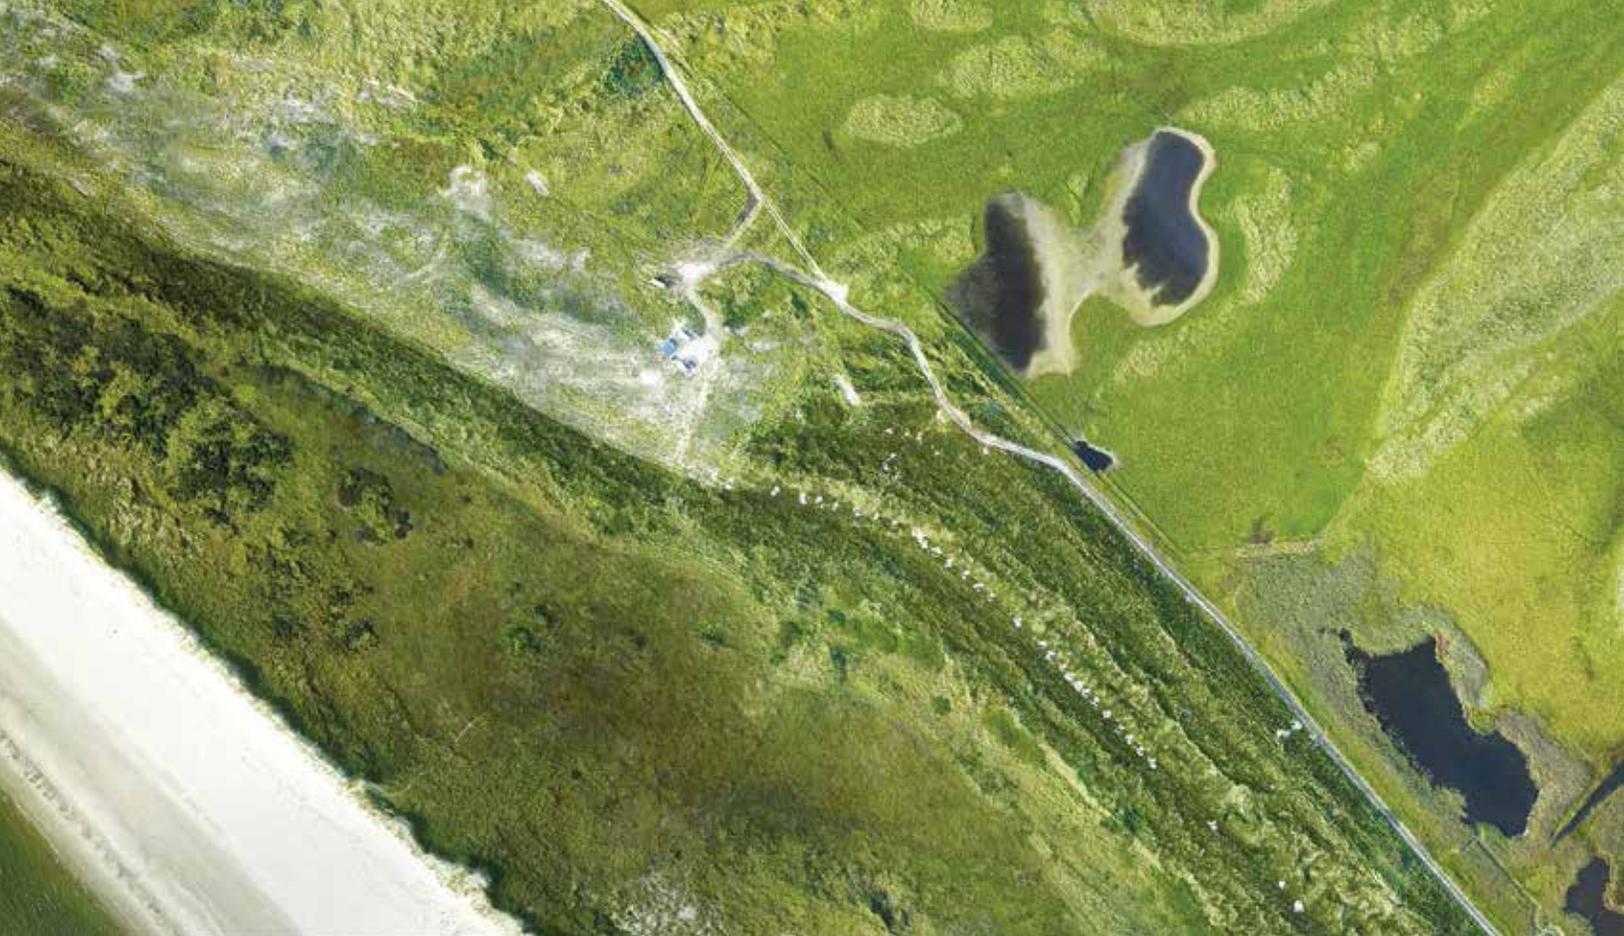
After approximately one year, the old vegetation that was spread on top of the dune has started growing again and the dune appears undisturbed. The former cleared area is seen in the upper left corner.

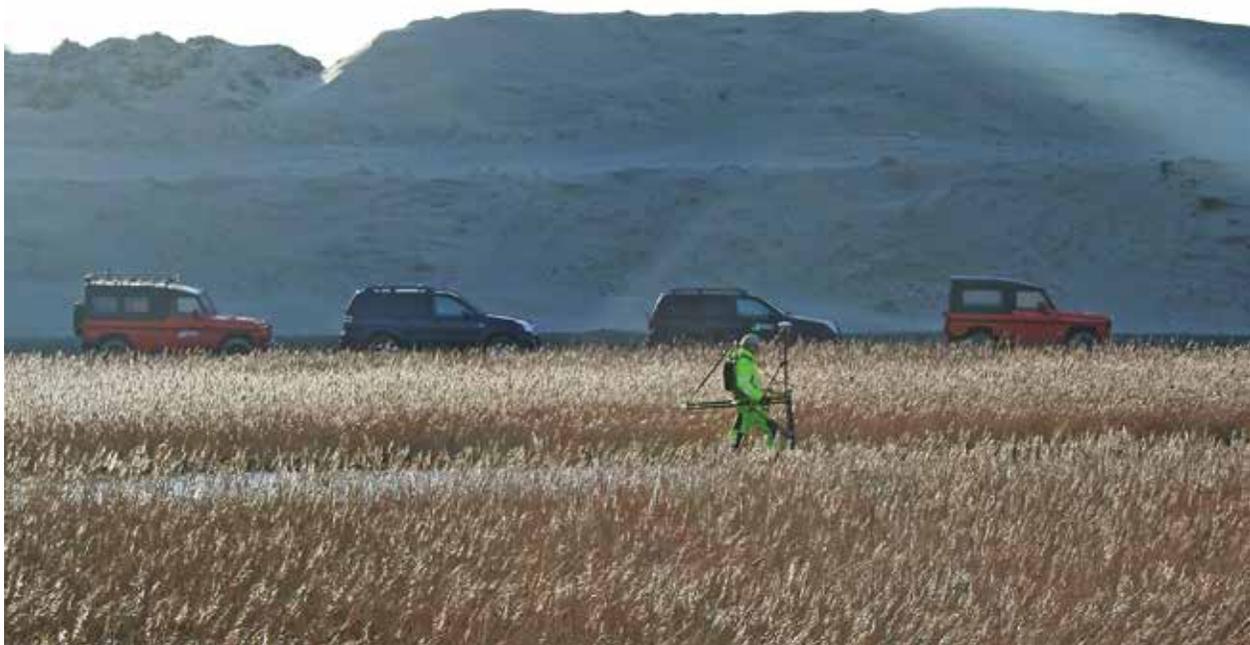
Data-logging in the marsh had little impact on the environment and increased the pace of clearance.

functionality of the mines determined the security level. It was therefore possible to choose methods in compliance with the EIA. Further, the survey results made it possible to data-log large areas of the marsh, which made clearance more efficient and cost-effective.

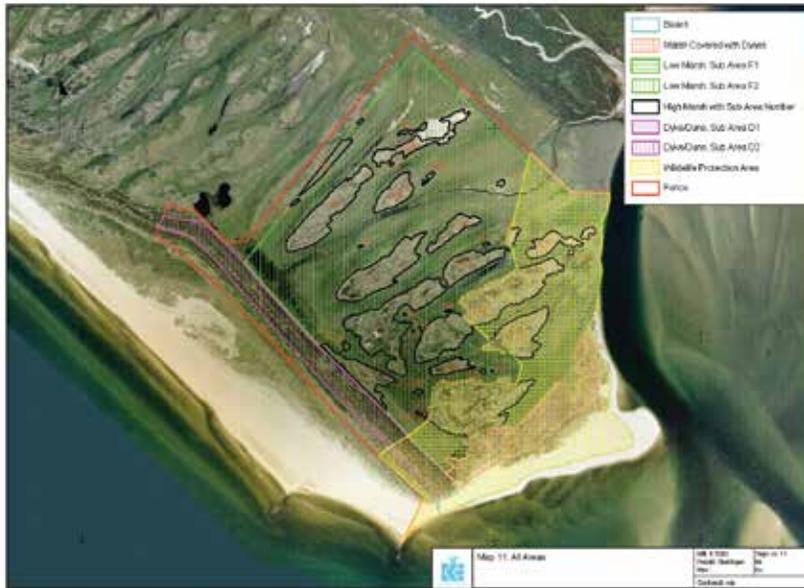
Figure 1. Using knowledge gained during surveys and analysis on functionality and depth of mines, together with the EIA, it was possible to divide the area into five subareas (beach, dune, marsh covered with dune, low marsh, and high marsh). Each of these areas was cleared using different methods hereby fulfilling the mitigation measures. Some areas had to be subdivided as they were part of the restricted wildlife area. The surveys not only led to clearance having a low environmental impact but also reduced overall expenses as marsh and beach areas were safe to walk across.

These two surveys made it possible to use different clearance techniques in different areas, resulting in a low environmental impact (Figure 1, page 43).<sup>6</sup> The depth of the mines influenced the clearance and detection method whereas the
